CASE STUDY

Reconstruction of a Displaced Distal Radius with Volar Lunate Facet Fragment

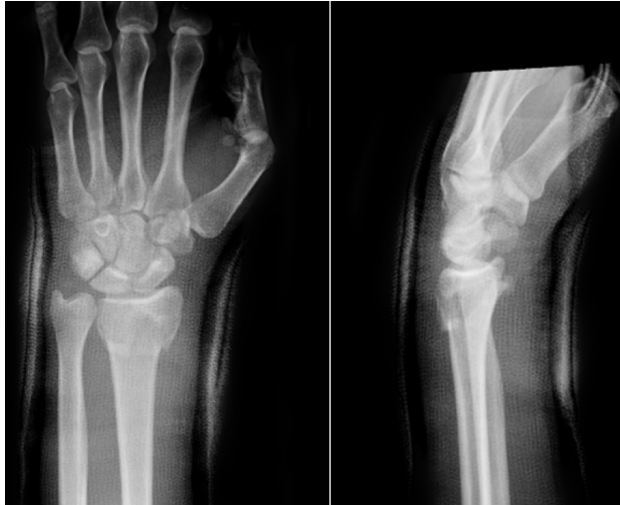
Figure 1A: Pre-Op Distal Radius Fracture

Initial x-rays show displaced distal radius fracture without ulnar fracture (Figure 1A). Subsequent CT scan of the distal radius demonstrated 23-C3 complete intra-articular fracture of the distal radius with comminution visualized on axial, coronal, and sagittal imaging (Figures 1B, 1C, and 1D, respectively). Notably, the fracture line was very distal at the ulnar margin, commonly referred to as the volar lunate facet. The patient was indicated for operative intervention with open reduction and internal fixation.

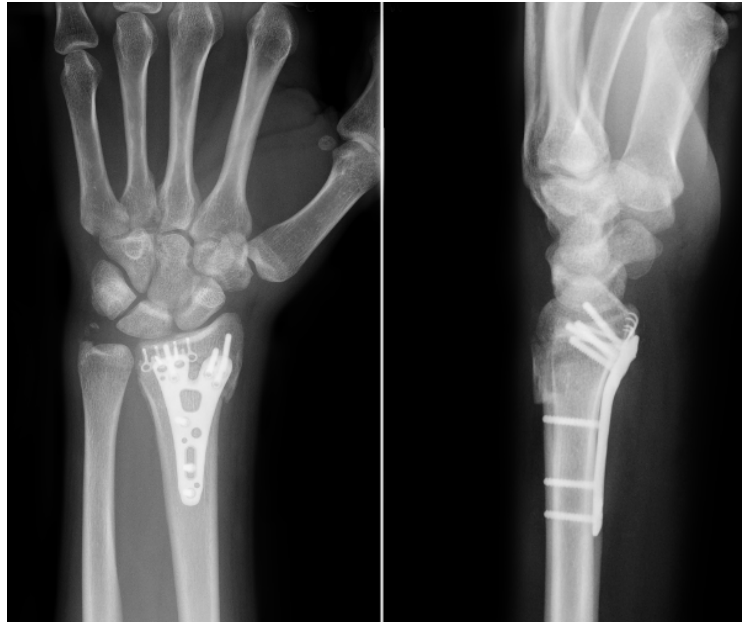
Figures 2 and 3: 2-weeks Post-Op

Four 1.5 Speedtip screws were inserted to the hook plate to stabilize it beneath the volar plate, ensuring their trajectory was aiming proximal, away from the joint line. Final fluoroscopic images demonstrated fracture reduction with no intraarticular screw penetration and Soong grade 1 volar plate prominence. Evaluation of wrist range of motion produced no evidence of instability or prominent hardware at the distal radial ulnar joint (Figures 2 and 3).

Open reduction and internal fixation of the distal radius was achieved with particular attention paid to stabilization of the volar lunate facet with the 4-hole hook plate. This plate allowed for lower profile plate prominence distally without sacrificing stabilization. The patient had a good functional result with no restrictions in range of motion or weightbearing activities. Additionally, there was no fracture subsidence, tendon irritation, or rupture requiring additional surgery in his postoperative course. The Medartis volar hook plate can be considered in distal fractures where volar and distal plate prominence may cause flexor tendon irritation.
