CASE STUDY

Reconstruction of a Displaced Radial Shaft Fracture Using the APTUS XL Volar Plate

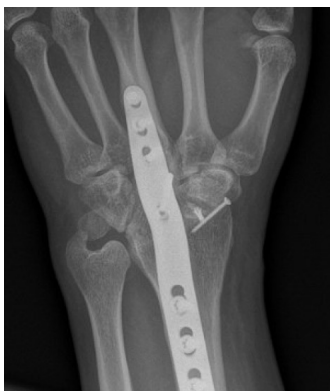
Figure 1

In 2019, the patient sustained a complex trans-radial styloid, trans-scaphoid, trans-triquetral perilunate fracture dislocation following a fall from a height of 20 feet. He was treated with a primary wrist fusion at that time (Figure 1). Pre-operative X-rays obtained demonstrated a displaced fracture of the radial shaft located proximal to the wrist fusion plate (Figure 2).

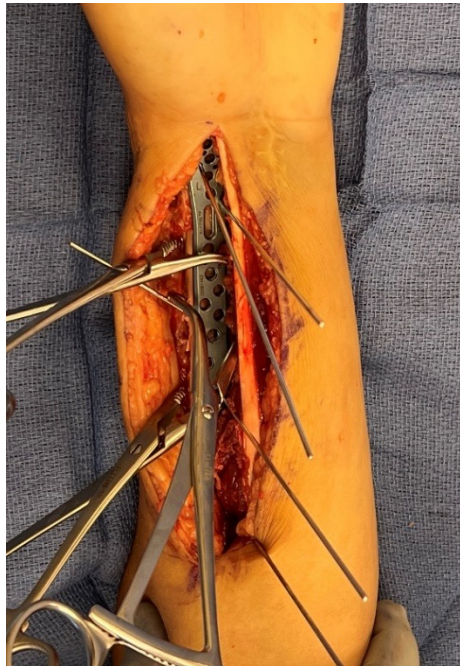
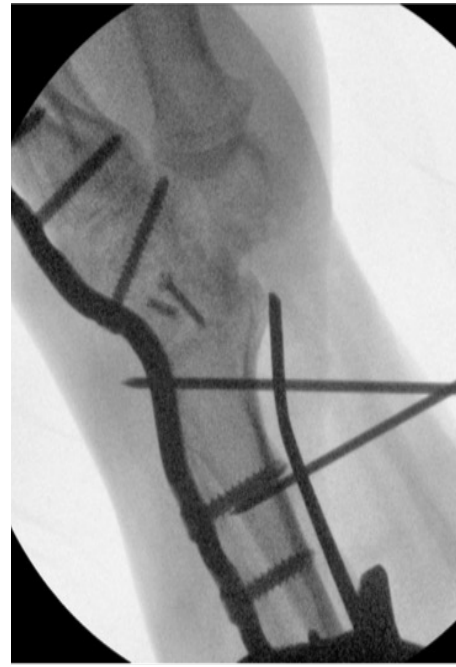
A large 10 cm volar exposure was performed to expose and anatomically reduce the fracture. The reduction was temporarily held with clamps and K-wires. A Medartis meta-diaphyseal XL volar plate was utilized to fixate the fracture. (Figures 3 & 4)

The APTUS XL Volar plate provides good fixation options for diaphyseal radius fractures. The anatomical pre-contoured plate design and multiple proximal screw fixation options with the offset screw hole alignment was of great benefit in this case which required consideration for a pre-existing dorsal wrist fusion plate.

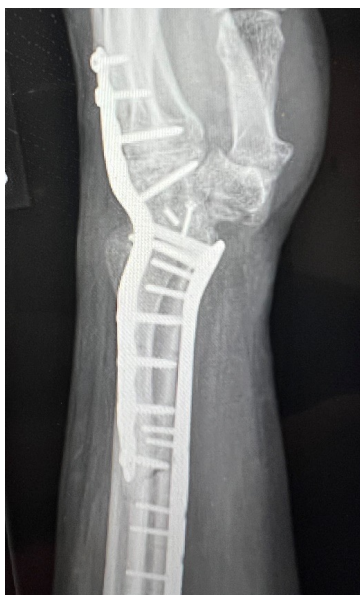
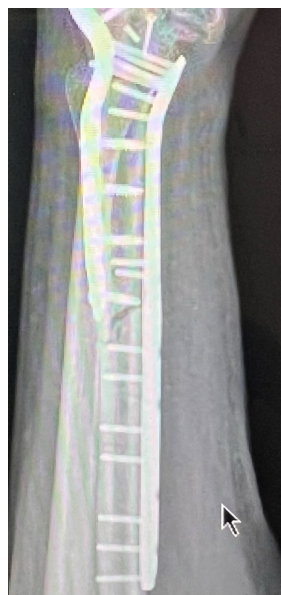
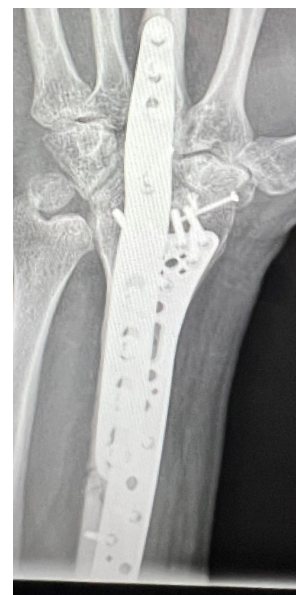
The patient was placed in a short arm splint for 6 weeks. His X-rays at 6 weeks revealed bony trabeculae crossing the fracture site indicating bony ingrowth was forming.

At the 6-week postoperative mark, the patient reported no pain and had no fracture tenderness. He had full finger range of motion and full pronosupination. Due to the previous wrist fusion, there was no rotational or sagittal motion in the wrist joint. The patient returned to work the following week as a plumber. (Figures 5,6,7).
